*Completion of the North Orange  
By-pass from Astill Drive (North)  
to Chinaman's Bend, Orange*

## Soils Assessment

SEEC Morse McVey

March 2009

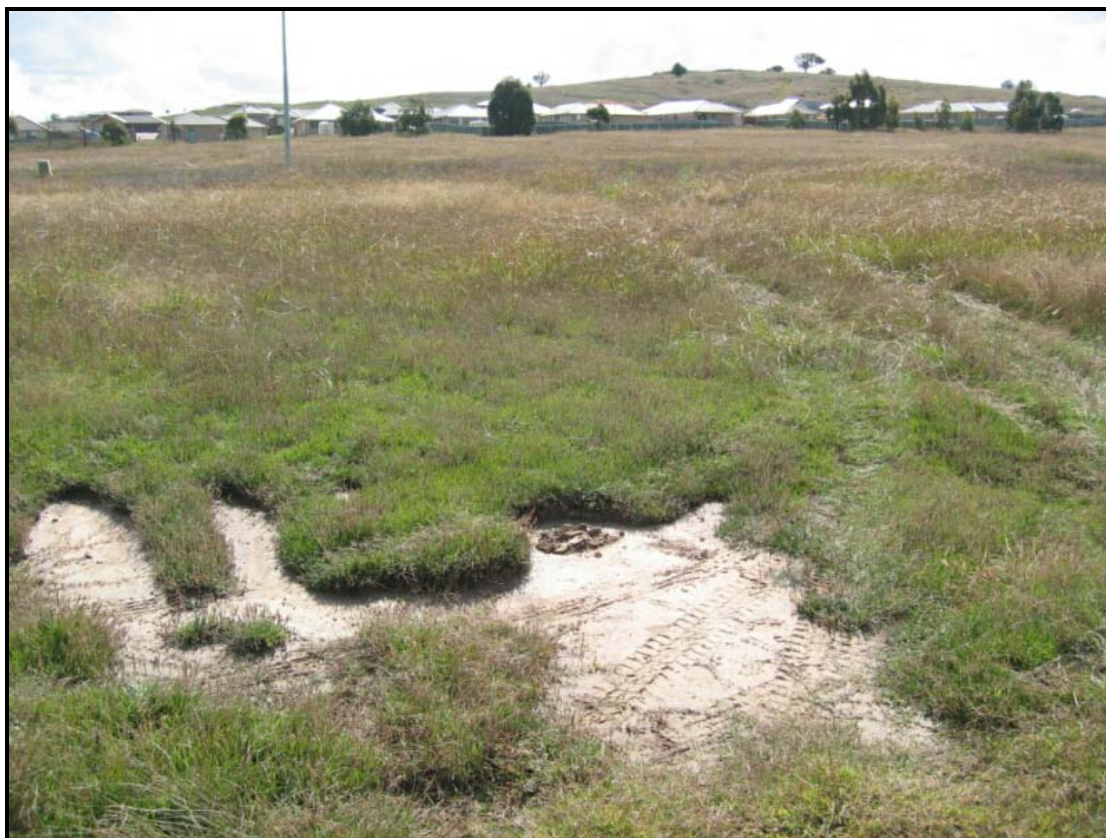
**Figure 3**  
**Surface Discharge of Saline Groundwater causing Vegetation Decline**

The occurrence of this saline seepage scald indicates that salts are a naturally-occurring phenomenon in the subsoils of the Byng footslopes. Under most conditions, these salts remain undissolved in the soil. However human or construction activities can cause elevated groundwater tables to dissolve these salts and rise into the plant root zone or the compacted zone beneath an engineered structure (e.g. a road). This can cause vegetation decline and can damage structures.

**Table 6** presents the results of pH testing for representative soil samples. The saline seepage at TP15 was found to be very strongly alkaline. This is typical of highly saline soils and, along with the influence of the saline water, will cause vegetation to die. Similarly, salt-affected soils will be unsuitable as a growth medium for vegetation during site stabilisation works following construction.

At the existing discharge point near TP15, the road will need specific measures included in its design to minimise the risk of pavement damage. In this location, we recommend that a capillary break (e.g. Tensar Geogrid or equivalent) be installed below the pavement to divert any elevated groundwater laterally into the adjacent stormwater drainage system. This will also help to stiffen the pavement.
